A Novel Method for Confirming the Presence of Volatile Reduced Sulfide Compounds via Inductively Coupled Plasma-Optical Emission Spectroscopy

Krystal Lynne Parker
University of Southern Mississippi

A Thesis
Submitted to the Graduate School
of The University of Southern Mississippi
in Partial Fulfillment of the Requirements
for the Degree of Master of Science

December 2014

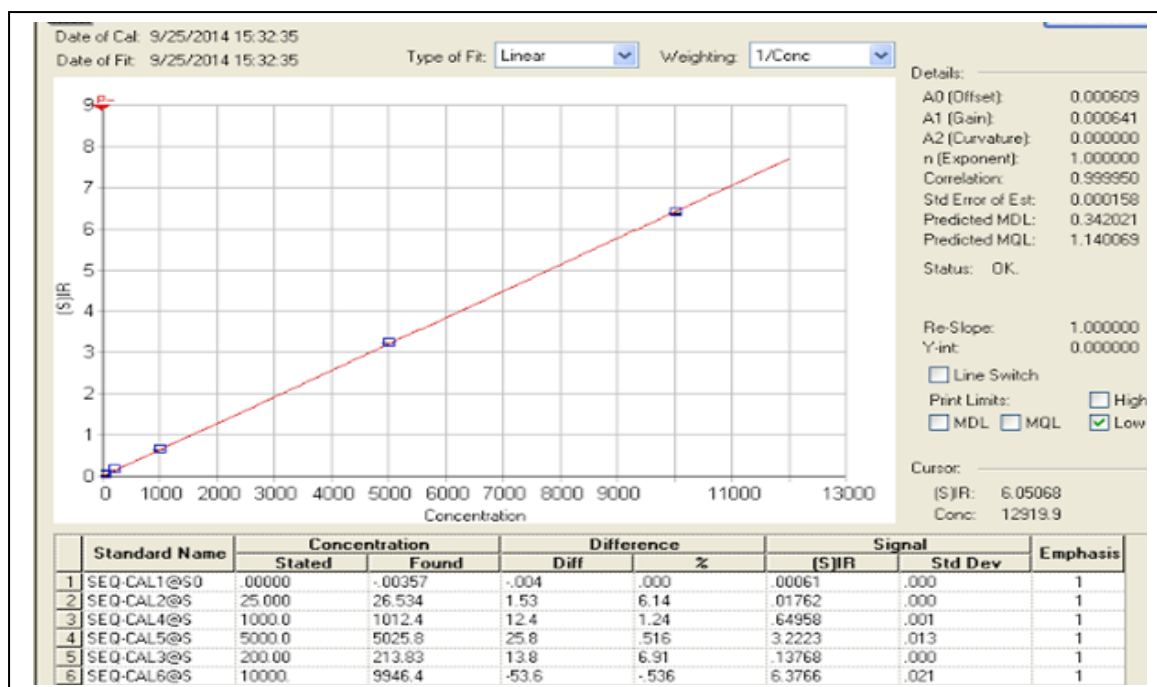
Figure 1. Calibration curve for copper. Correlation coefficient of 0.999950 and %RSD of $\pm 7\%$.

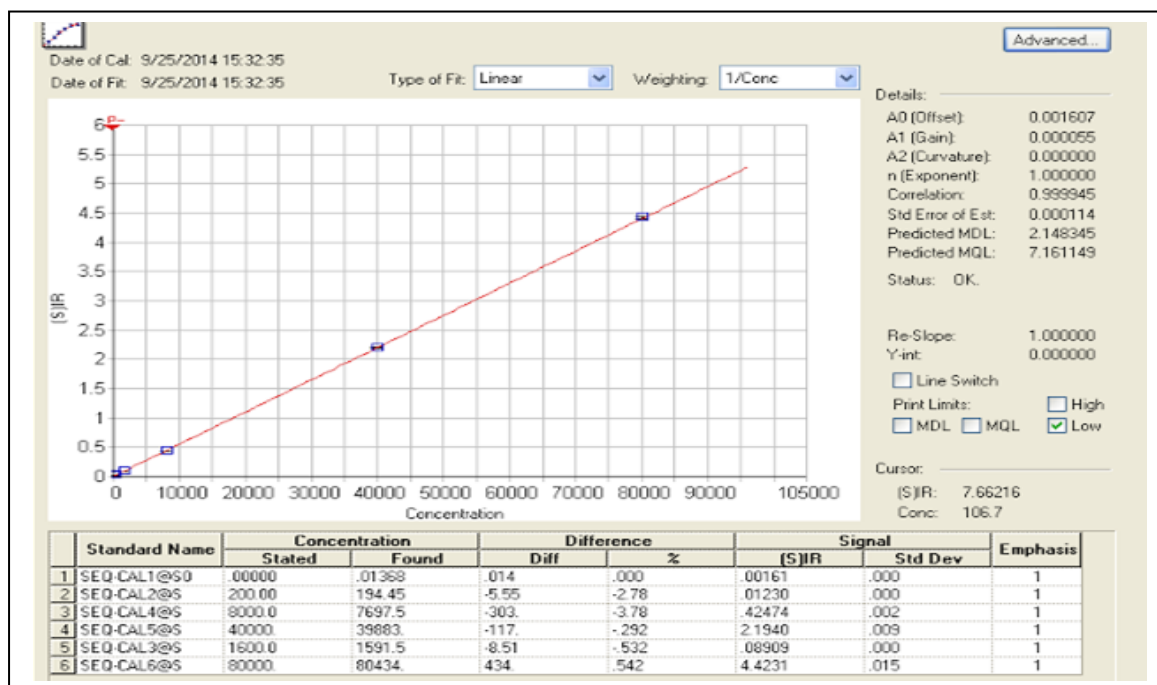
Figure 2. Calibration curve for sulfur. Correlation coefficient of 0.999945 and %RSD of $\pm 4\%$.

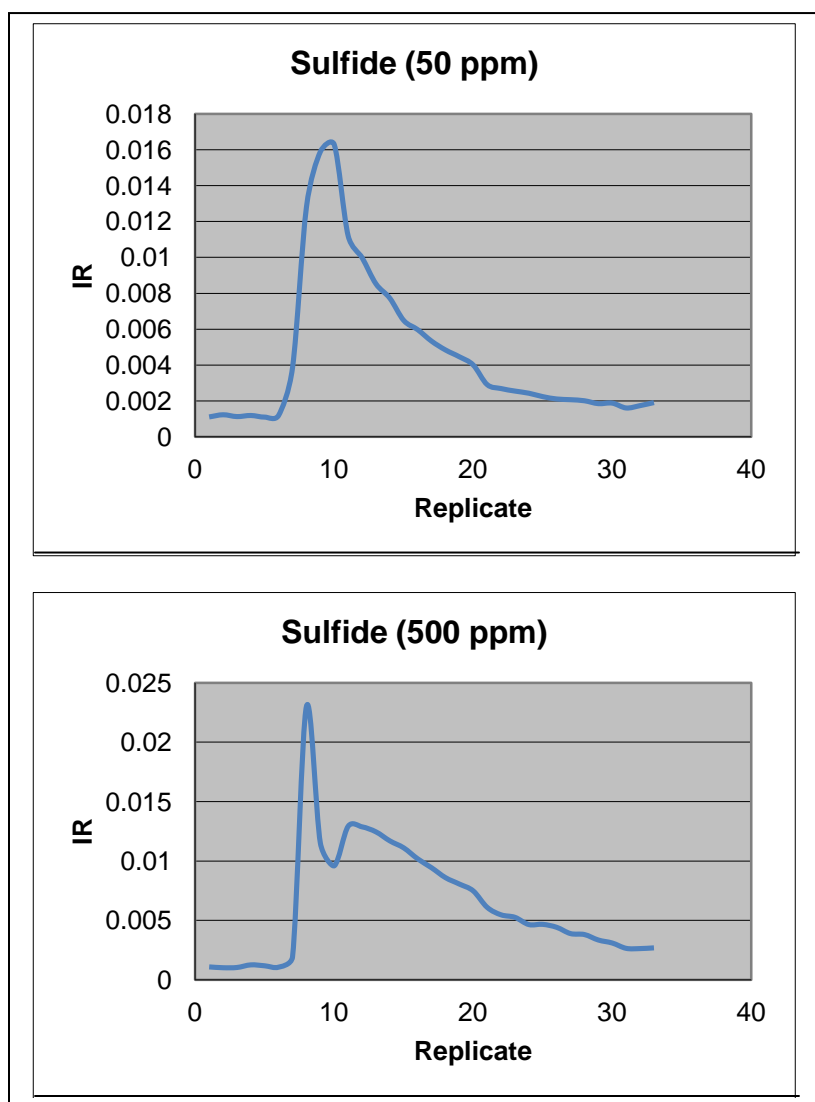
Figure 3. Analysis of the 50 ppm and 500 ppm samples. These were made from the sodium sulfide standard in order to test developed method.

The method was then modified to only test for copper and sulfur based on these results along with the results of the IECs and MDL studies. The samples made from the standard were also used in order to modify the method further. Once the method was switched to real time analysis, they helped determine how many replicates needed to be done and at what repeat the piece of copper needed to be dropped in at. It was determined that 40 replicates needed to be done, and the copper needed to be dropped in after the fifth replicate in order to obtain results where a baseline could be seen towards the beginning and end of analysis. The same samples were used to show that the developed method worked best when the exposure time for low axial was set at 30 seconds and set at one second for all other views including high axial, low radial, and high radial. The number of replicates along with the exposure times resulted in sound data. The results of the samples made from the sodium sulfide standard can be seen in Figure 3.

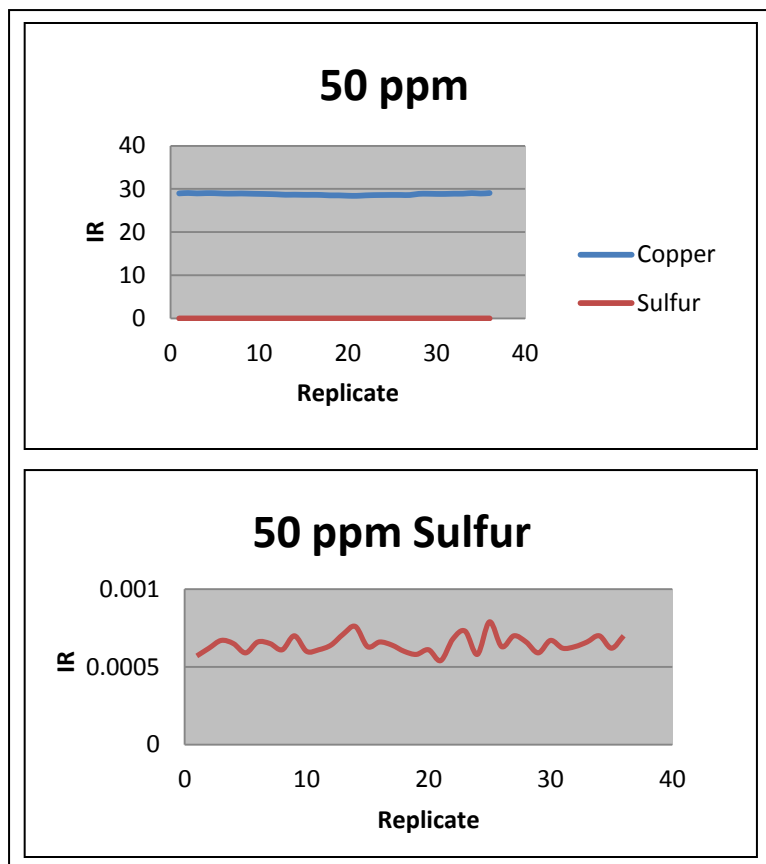
Figure 4. Analysis of the oxidized copper from sulfide standard at 50 ppm. Sulfur results were magnified in the second graph.

The samples made from the sulfide standard were also used to show that a modified 3050B method cannot be used for analysis to positively identify if drywall is Chinese drywall or not by looking at sulfur content. The certified 3050B method uses nitric acid and hydrochloric acid in order to break down complex metals. It also uses hydrogen peroxide in order to break down complex organics. Based on previous research, these reagents would cause the gaseous sulfide compounds to volatilize. The hypothesis,

which was later proven valid, was that the sulfur would volatilize out of the sample during the digestion procedure, and only copper would be seen in the analysis. One can see that this occurred for both the 50 ppm and 500 ppm samples in Figures 4 and 5. The first graph in Figure 4 depicts an instrument response around 30 for each replicate of copper shown in blue, while the instrument response for sulfur is around zero for each replicate shown in red. The second graph in Figure 4 is just a magnification of the instrument response for sulfur at all replicates, which shows the response was between 0.0005 and 0.001. The first graph in Figure 5 depicts an instrument response around 20 for each replicate of copper shown in blue, while the instrument response for sulfur is around zero for each replicate shown in red. The second graph in Figure 5 is a magnification of the instrument response for sulfur at all replicates, which shows the response was between 0.0005 and 0.001. One can also see that since the copper was in solution due to the digestion procedure, no baseline could be obtained in both of the analyses.

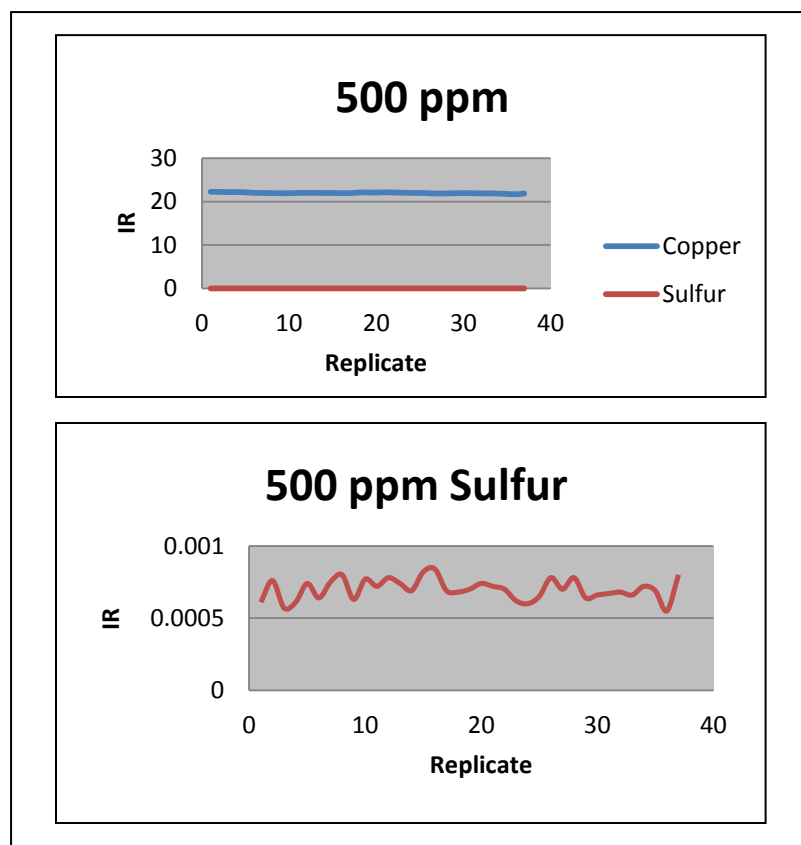
Figure 5. Analysis of the oxidized copper from sulfide standard at 500 ppm. Sulfur results were magnified in the second graph.

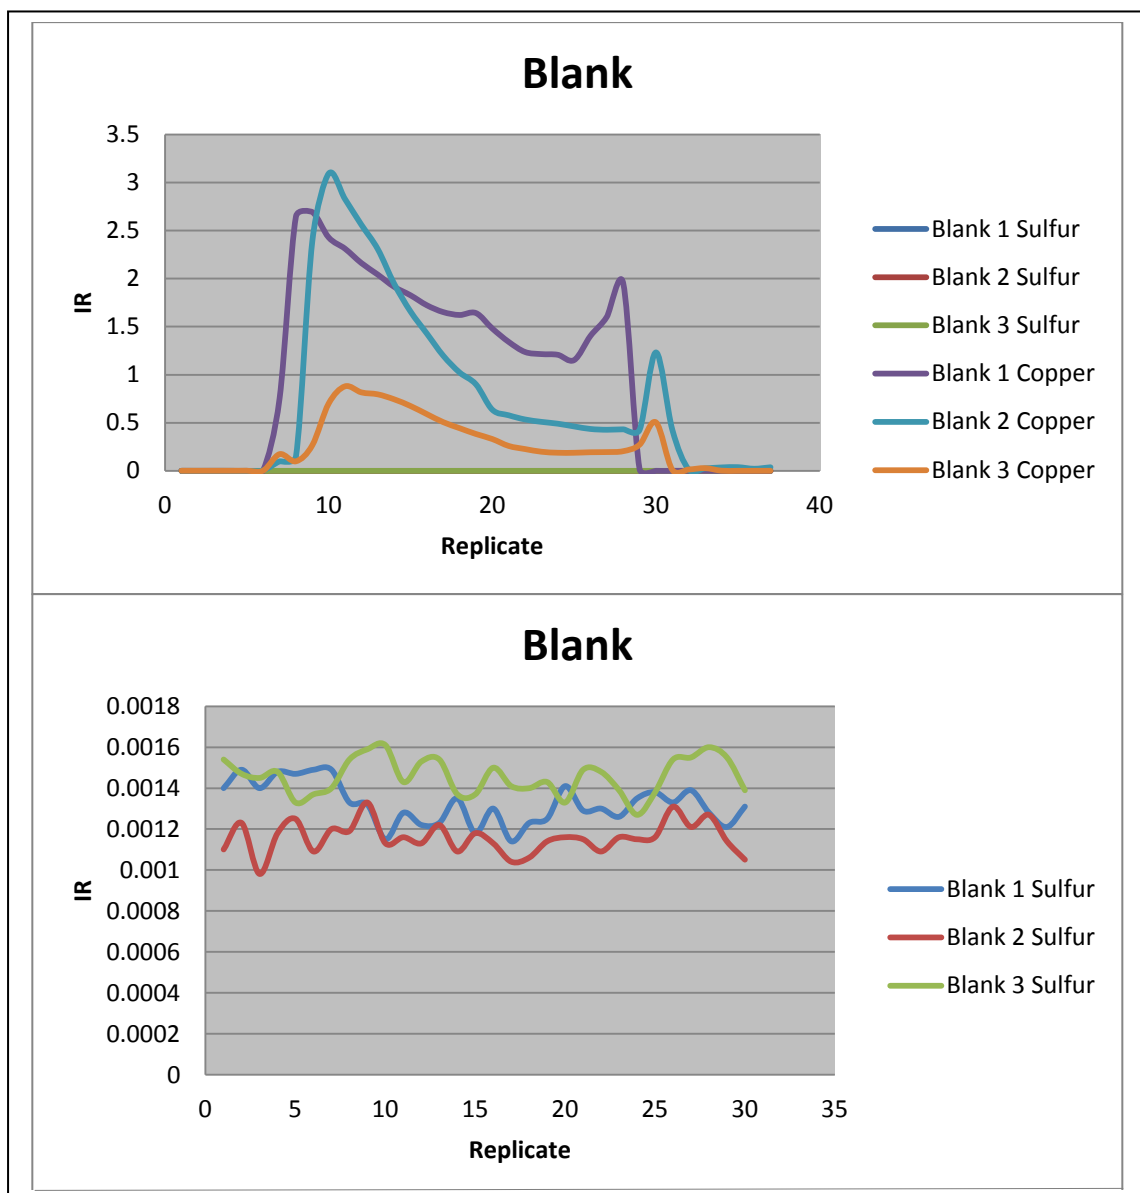
Figure 6. Real time analysis of all three blanks. Second graph shows magnification of sulfur results.

Once the method was finalized, real time analysis was done on the fifty Chinese drywall samples prepared in a natural environment. A blank sample of just a piece of copper was run for every twenty samples, and a duplicate was run for every ten samples to prove reproducibility. A control of just regular drywall was also analyzed. The blank and control showed no evidence of sulfur as can be seen in Figures 6 and 7. Figure 6 depicts the instrument response for all replicates for copper and sulfur in all three blanks. The results for copper for the first blank can be seen in purple, the second blank in light blue, and the third blank in orange. The results for sulfur for the first blank are in dark blue, the second blank in red, and the third blank in green. Since all three results were around zero, the second graph shows a magnification of all three sulfur results in order to show the instrument response results were between 0.001 and 0.0016. Figure 7 depicts

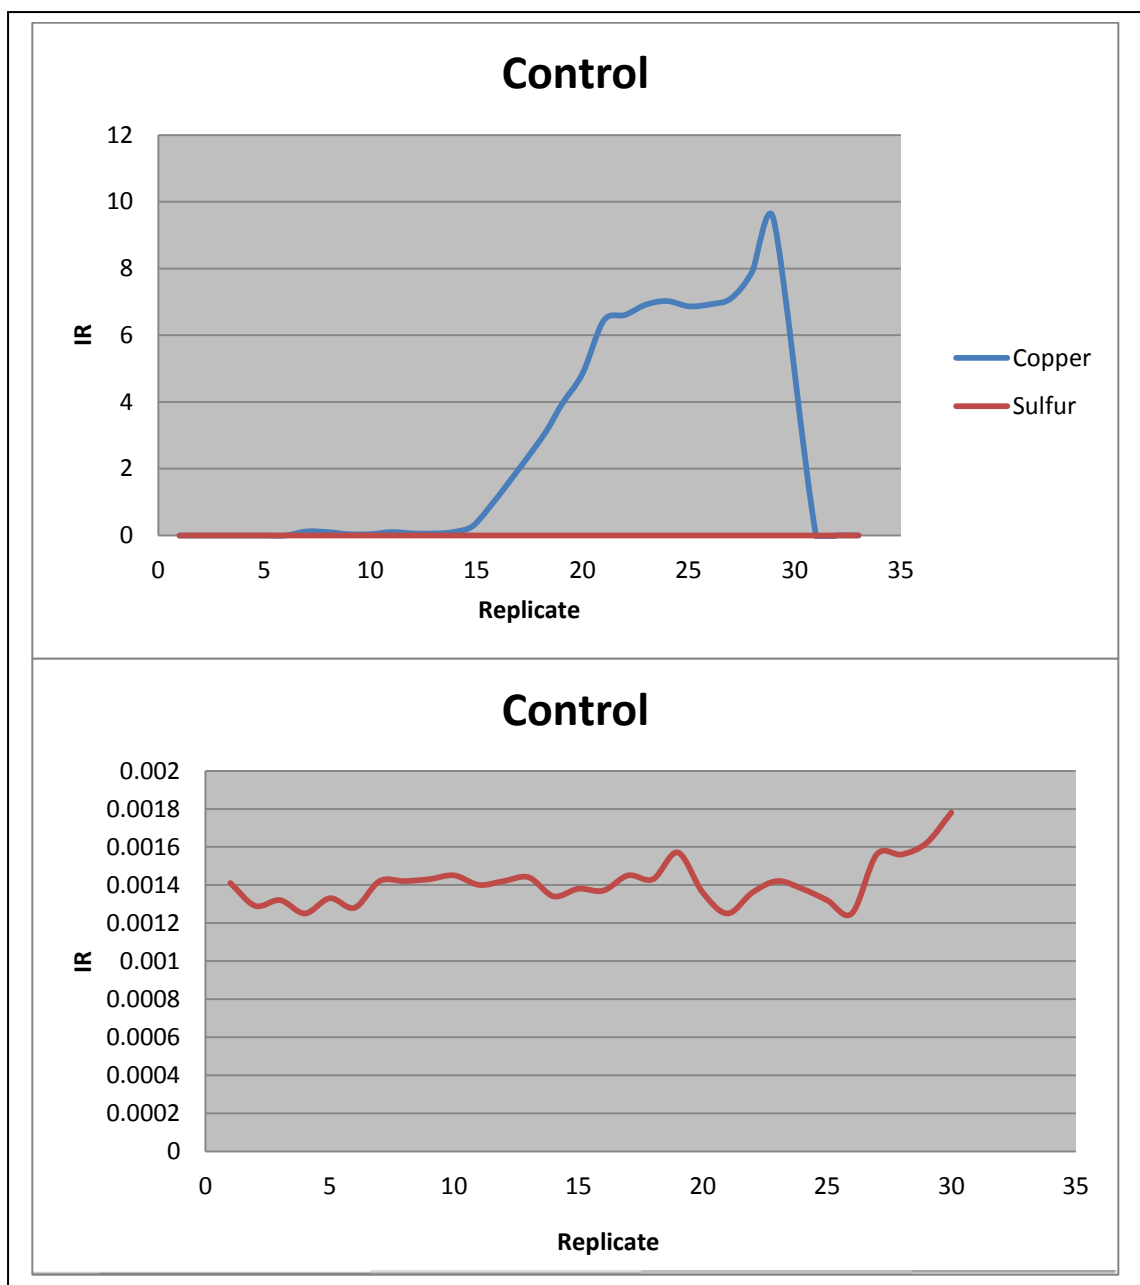
Figure 7. Real time analysis of control drywall sample. Second graph shows magnification of sulfur results.

the instrument response for all replicates for copper and sulfur in the control sample. The results for copper can be seen in blue, while the results for sulfur are in red. The second graph is to depict the magnification of the sulfur results in order to show they were between 0.0012 and 0.0018, specifically.

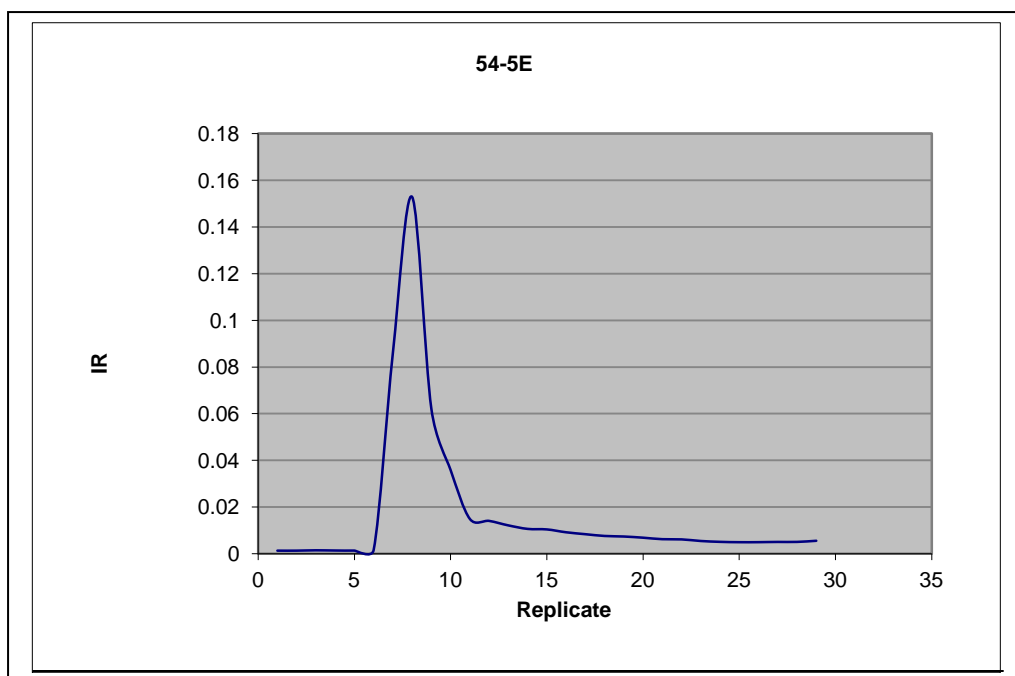
Figure 8. Graph of the instrument response versus the replicate number for sample 54-5E. Twenty-four samples, including this one, had a pattern like this where the initial reading was a baseline, then a peak observed, then it fell back down close to the baseline again.

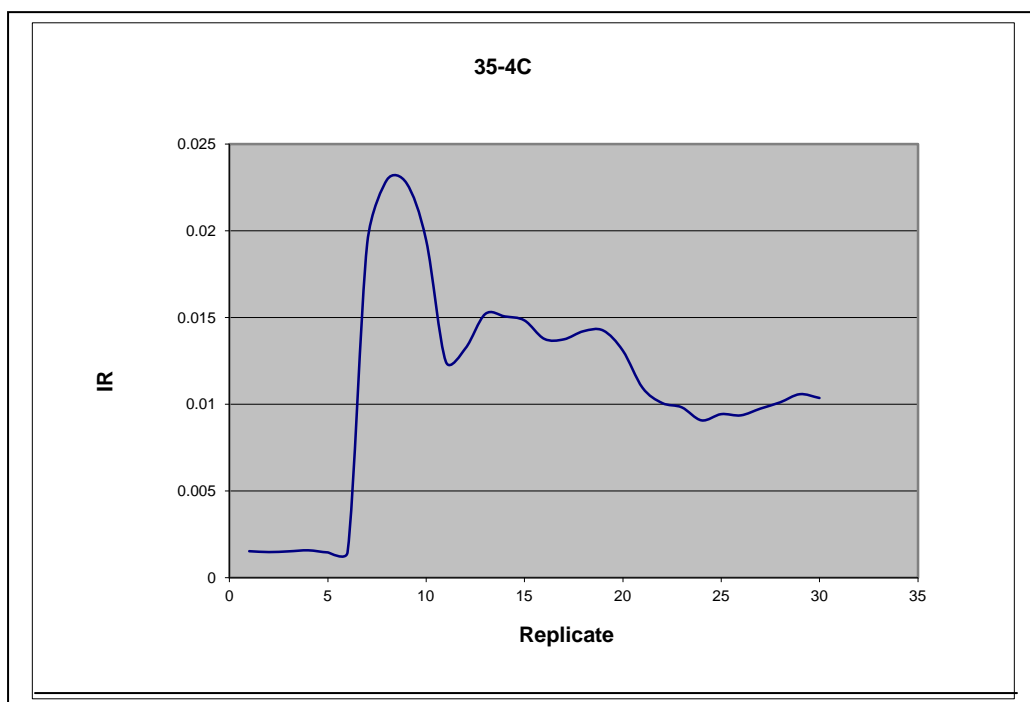
Figure 9. Graph of the instrument response versus the replicate number for sample 35-4C. Ten samples, including this one, had a pattern like this where the initial reading was a baseline, then it peaked, and then it did not quite fall back down to the baseline.

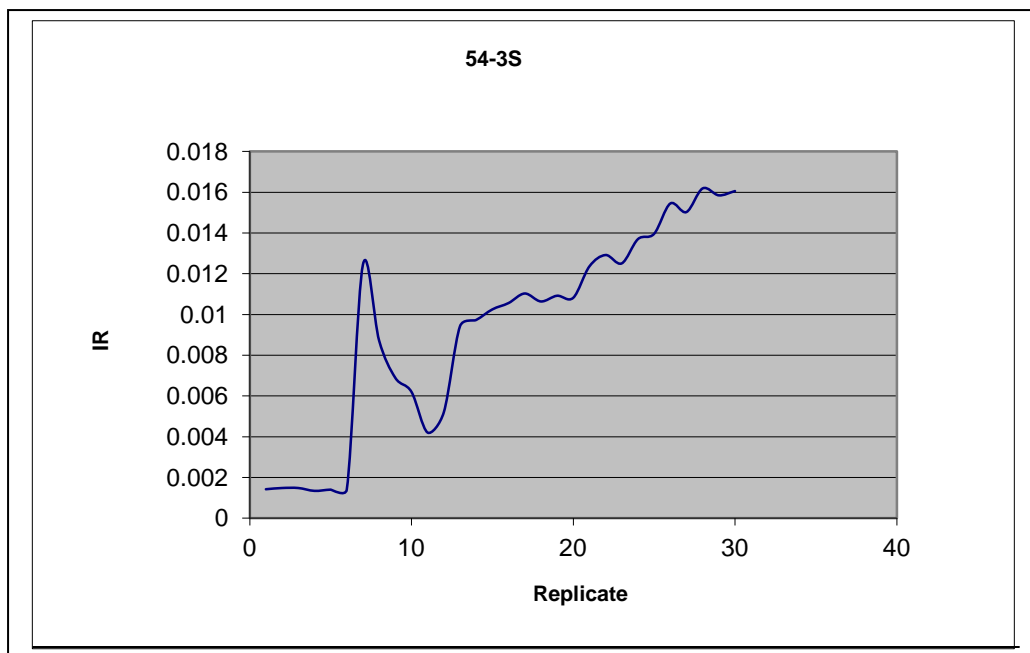
Figure 10. Graph of the instrument response versus the replicate number for sample 54-3S. Nine samples, including this one, had a pattern like this where the initial reading was a baseline, then it peaked, and then it either peaked a second time or looked like it was about to instead of going back down towards the baseline.

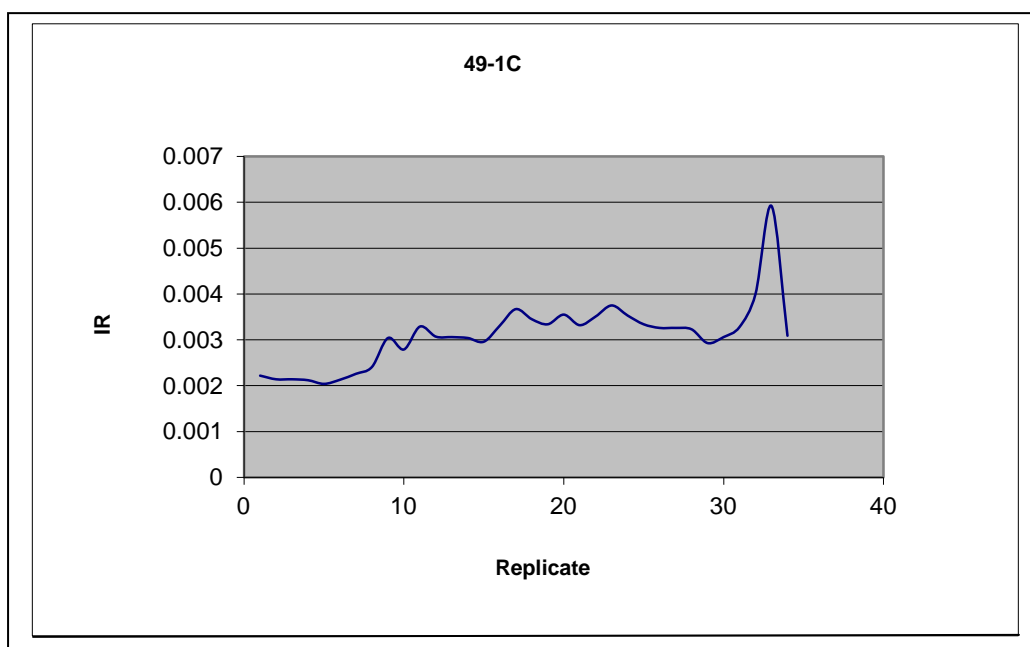
Figure 11. Graph of the instrument response versus the replicate number for sample 49-1C. Five samples, including this one, had a pattern like this where the initial reading was a baseline, then it peaked, and then it fell back down towards the baseline. However, the peak occurred more towards the end of the forty replicates instead of towards the beginning.

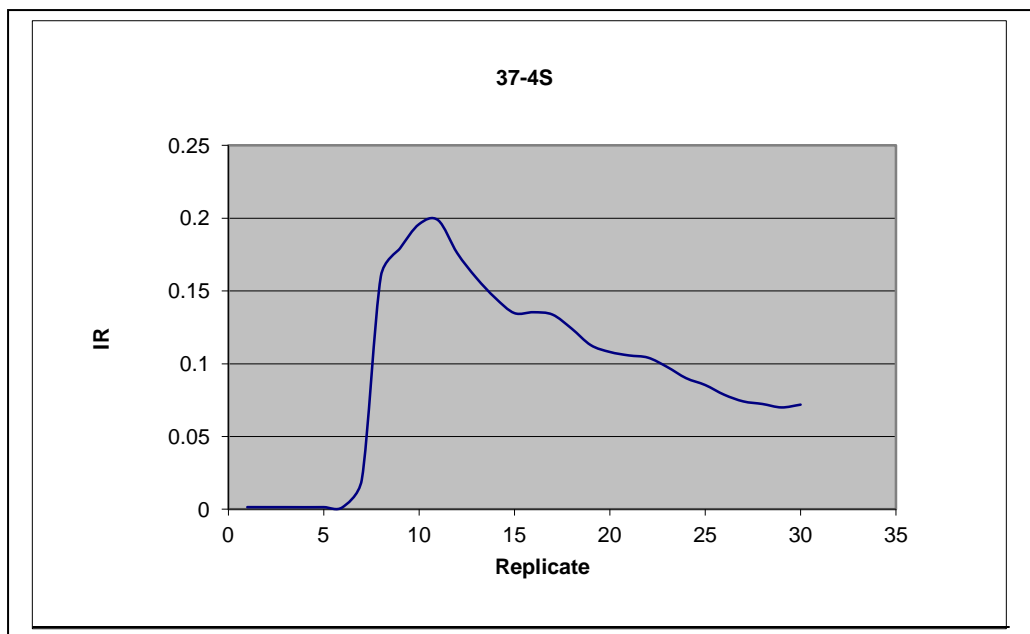
Figure 12. Graph of the instrument response versus the replicate number for sample 37-4S. Two samples, including this one, had a pattern like this where the initial reading was a baseline, then it peaked, and then it fell back down towards the baseline. However, the peak was more broad instead of narrow. These samples may not have completely gone into solution.

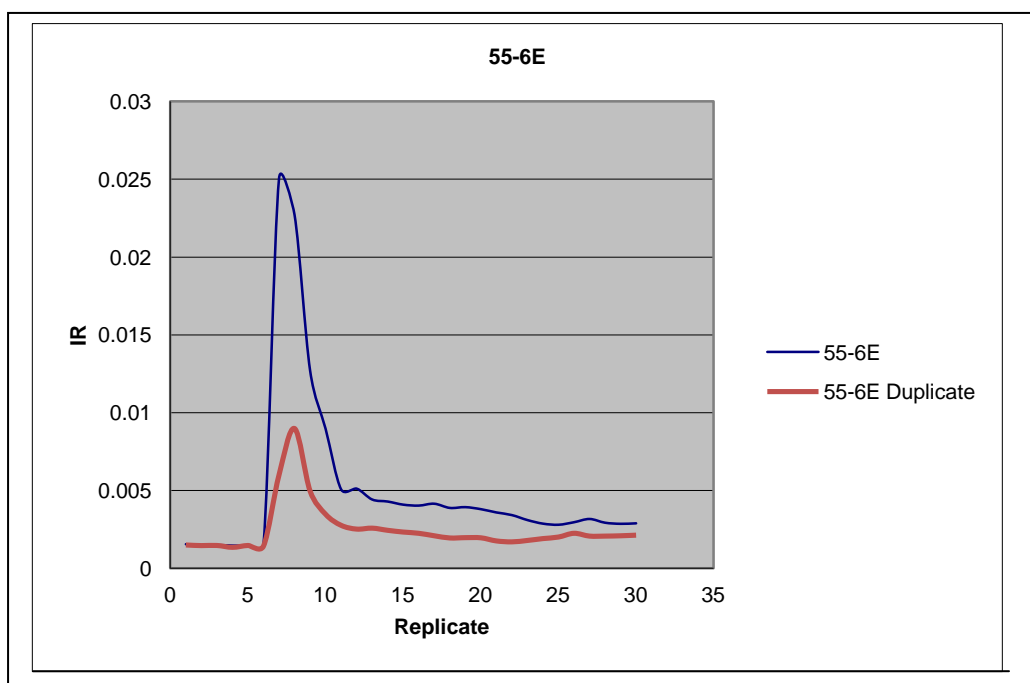
Figure 13. Graph of the instrument response versus the replicate number for sample 55-6E. Three of the samples run in duplicate, including this one, had a pattern like this where the initial reading was a baseline, then a peak occurred, then it fell back down close to the baseline again.

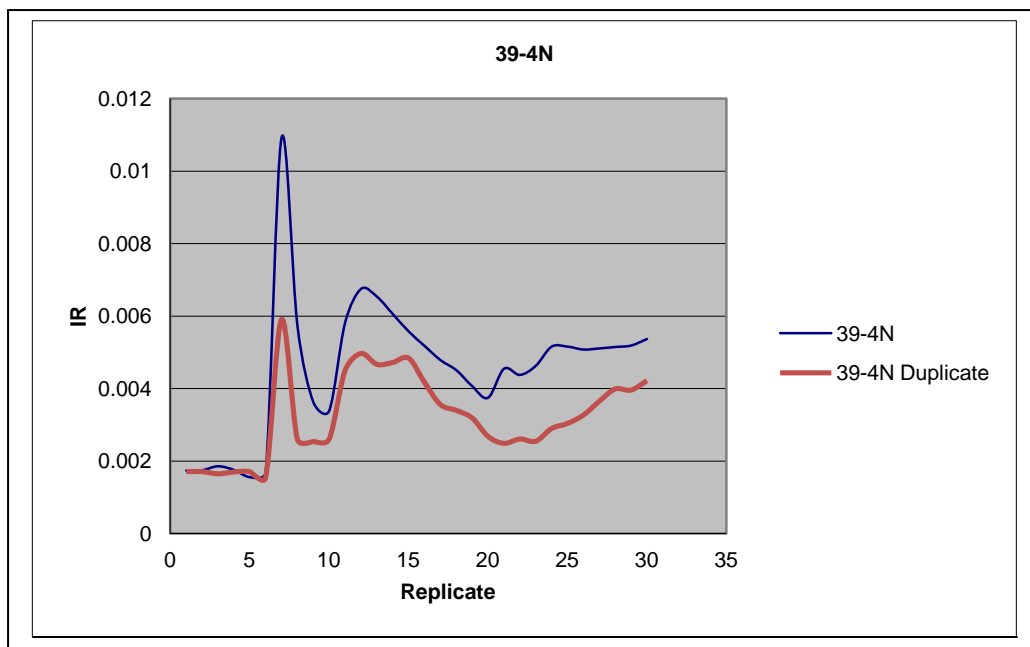
Figure 14. Graph of the instrument response versus the replicate number for sample 39-4N. This sample run in duplicate had a pattern where the initial reading was a baseline, then it peaked, and then it did not quite fall back down to the baseline.

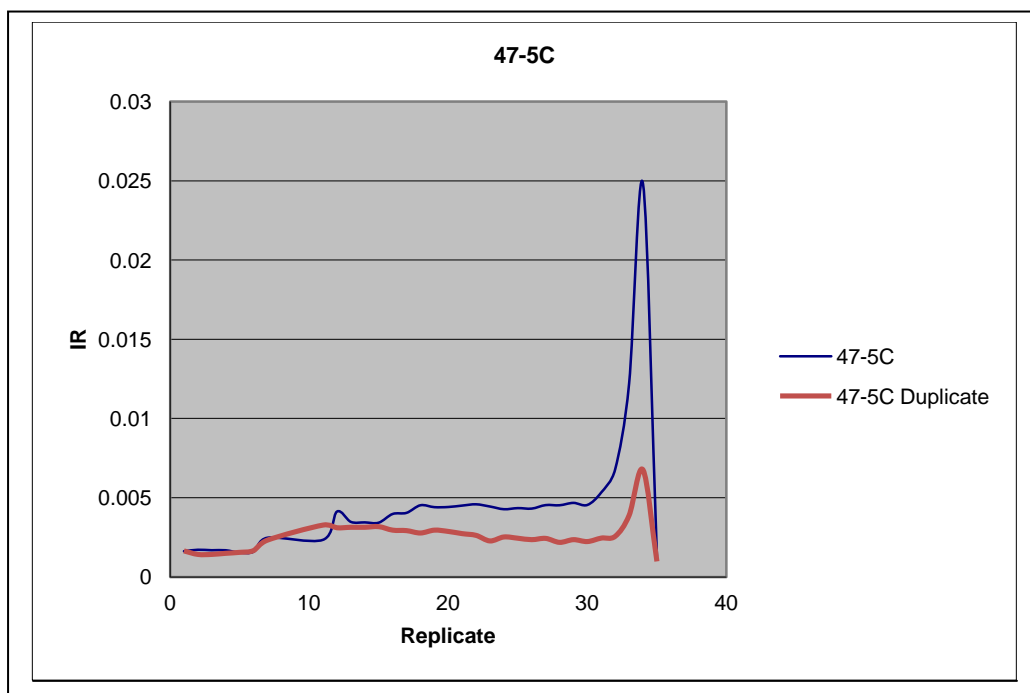
Figure 15. Graph of the instrument response versus the replicate number for sample 47-5C. This sample run in duplicate had a pattern where the initial reading was a baseline, then it peaked, and then it fell back down towards the baseline. However, the peak occurred more towards the end of the forty replicates instead of towards the beginning.
