SCIENTIFIC REPORTS

Erosion and sedimentation during the September 2015 flooding of the Kinu River, central Japan

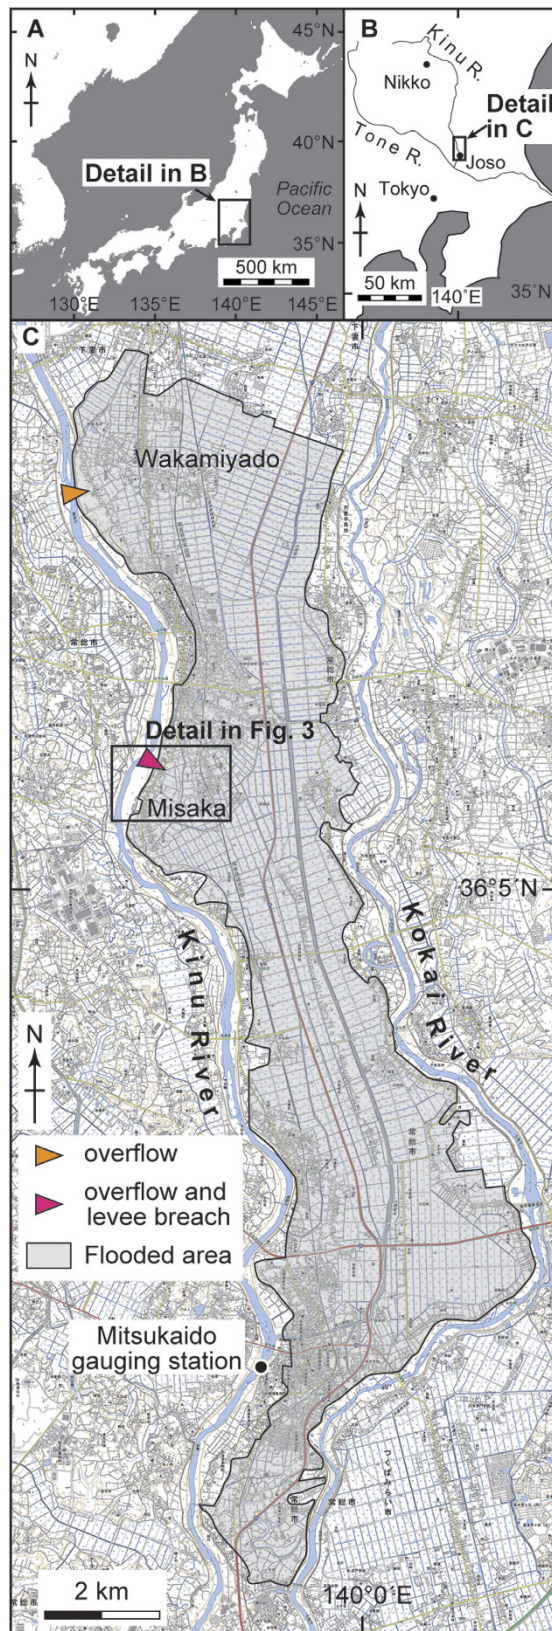
Figure 1. Location map of the study area. (A) General map of Japan. (B) Map of the Kinu River in central Japan. (C) Index map around the study area in Josso City showing the flooded area, position of the Mitsukaido gauging station, and the overflow and levee-breach points along the Kinu River during the 2015 flooding. GMT 4.5.6 software³⁵ was used to prepare the maps in panels (A) and (B). A Digital Topographic Map 25000 from the Geospatial Information Authority of Japan³⁶ was used as the basemap in panel (C).

The Kinu River in central Japan is the main tributary of the Tone River which discharges into the Pacific Ocean (Fig. 1A,B). The Kinu River originates just north of Nikko City, flows for 180 km in a north-south direction (Fig. 1B), and has a slope gradient of 0.05–0.10% in its downstream area⁹. The river often overflows because it

Heavy rainfall triggered by a tropical storm occurred on 9–11 September 2015, leading to catastrophic river flooding around Joso City, central Japan (Fig. 1B,C). A meteorological station (Imaichi Station) located in central Nikko City (Fig. 1B) recorded 366.5 mm/day of rain on 9 September, which is the most intense rainfall event recorded at the station since 1978¹¹. Water levels in the Kinu River rapidly rose on 10 September as a result of the rainfall. In the downstream area of the Kinu River, the Mitsukaido gauging station in Joso City (Fig. 1C) recorded a maximum discharge of 4000 m³/s, which is the largest amount recorded at that location since 1936¹². At the station, water levels rose by 8 m over a 12 hour interval, and reached a maximum height of 17.134 m T.P. (Tokyo Peil; mean sea level of Tokyo Bay) at 10 a.m. on 10 September (Fig. 2), which exceeded the high water level (a threshold height for flooding relative to the neighboring levee height; 16.404 m T.P.). As a result, the Kinu River began to overtop its left bank at two locations in Joso City area (colored arrows in Fig. 1C) on 10 September. Flood waters overtopped the levees in Wakamiyado (orange arrow in Fig. 1C) at 6 a.m. and in Misaka (red arrow in Fig. 1C) at 11 a.m. Finally at 1 p.m., the 200-meter wide levee in Misaka was completely breached resulting in disastrous flooding⁹. Based on video analysis, the inundation flow velocity measured just behind the breached levee reached up to 4.5 m/s¹³. All the floodplain located between the Kinu and Kokai Rivers was inundated and the flood affected a 40 km² area around Joso City¹⁴ (Fig. 1C). The study area is located near the breached levee in the Misaka area in Joso City (Figs 1C and 3).

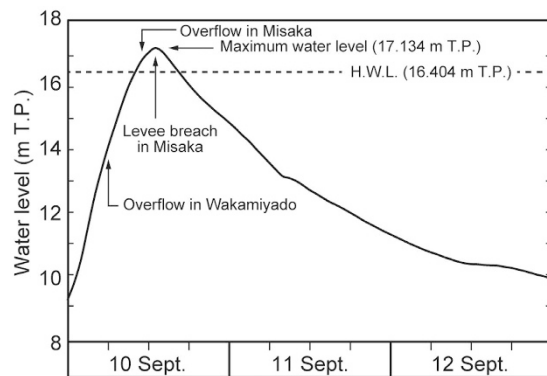
Figure 2. Hydrograph for the Kinu River at the Mitsukaido gauging station (Fig. 1B) from 10 to 12 September 2015. Measured water levels³⁷ were expressed compared to Tokyo Peil (T. P.; mean sea level in Tokyo Bay). H.W.L. means High Water Level at this station, a threshold height for flooding relative to the neighboring levee height.

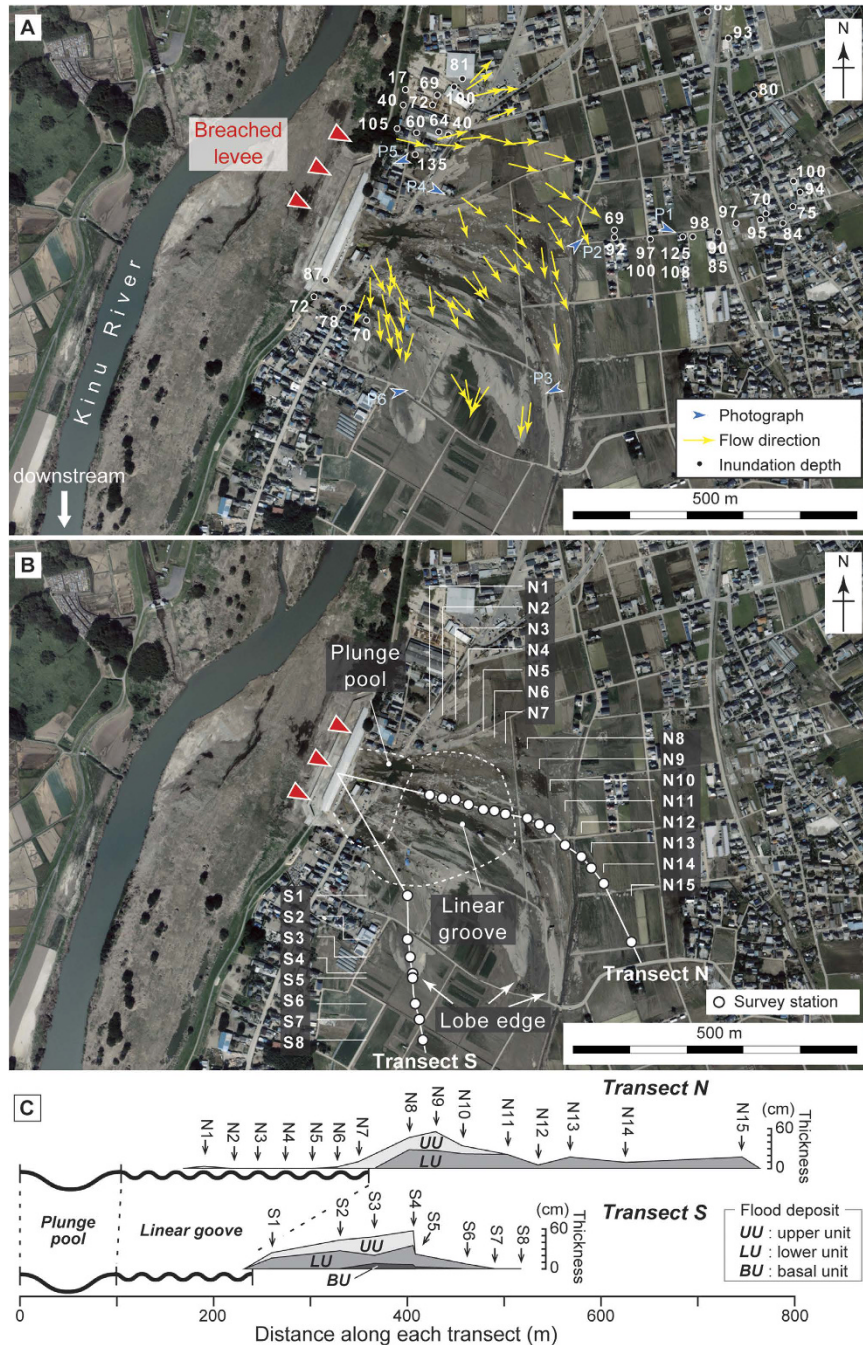
Figure 3. Detailed map of the survey sites with panels A and B displaying the same area. The aerial photo was obtained from the Geospatial Information Authority of Japan³⁸ (CKT-2015-12-C4-14) and taken on 29 September, 2015. (A) Map showing the survey locations on the photograph (blue arrowhead; Fig. 4), flow direction (yellow arrow) and inundation depth (black circle with the measured depth). (B) Map showing the survey stations where erosional and depositional features along Transects N and S were investigated. Transects N and S start at the breached levee and extend in the direction of flow. (C) Sectional view of the lateral distributions of erosional and sedimentary features along each transect from the breached levee. Note that erosional depths are not to scale.

The water depth during flooding, deduced from water marks and water-borne debris (Fig. 4A), was generally constant at most of the surveyed locations within the study area and ranged from 17 to 135 cm (83 cm on average) (Fig. 3A). Leaning plants, bedforms, and erosional scours (Fig. 4B–D) indicated an ESE–SSE flow direction that was perpendicular to the Kinu River flow in the area next to the breached levee (Fig. 3A). With increasing distance away from the breached levee, the direction of the flow gradually turned southward (Fig. 3A).

Numerous geomorphological features of erosion and sediment deposition resulting from the flooding were found within the study area. These features, including plunge pools, linear grooves and flood deposits, were exclusively found in a small area located next to the breached levee and were parallel to the main flow direction. Plunge pools, scoured by the flooding water, were several meters deep, 100 m wide and found at the toe of the breached levee's back slope (at P5 in Figs 3A,C and 4E). Roads and houses close to the plunge pools were completely destroyed and swept away. Adjacent to the plunge pools, numerous well-developed linear grooves were observed (Fig. 4D). The linear grooves were orthogonal to the Kinu River and found in a zone that extended for 250 m along the direction of flow. These grooves were observed at stations N1–7 along Transect N, and between the plunge pools and station S1 along Transect S (Fig. 3B,C). In the linear groove zone, up to 1 m of the pre-flood soil was laterally eroded, causing the underlying semi-consolidated muddy floodplain deposits to be exposed. Linear grooves that were several tens of centimeters deep and wide were dug further into the floodplain deposits as scour marks. The erosional surface was covered by either a thin mud drape (generally less than 1 cm thick; at N2–5; Fig. 3B) or by a thicker sandy flood deposit (generally several centimeters thick, with a maximum depth of 10 cm; at N1, N6–7; Figs 3B and 5). The flood deposit was limited to the area surrounding N1, N6–15 and S1–6 (Figs 3B,C, 5 and 6). In some places (N2–5, S7–8), only a thin mud drape overlay the surface. Bedforms such as unidirectional current ripples and dunes were widely found at the surface within the study area (Fig. 4C). At the midpoint between S4 and S5, the bedforms comprised a stepwise architecture resembling a deltaic lobe ranging heights comprised between 20–30 cm (Figs 3B,C and 4F).

Sedimentary and erosional features found in the flood deposits were laterally variable across the study area (Fig. 3C). The basal unit of the flood deposit was only found at three stations along Transect S. The lower unit was generally confined to areas distant from the breached levee, whereas the upper unit was generally confined to areas close to the breached levee. The lower unit of the flood deposit was found at stations N8–15 and S1–8, while the upper unit was found at stations N1, N6–10, and S1–4 (Figs 3B, 5 and 6). The latter overlapped the former at N8–10 and S1–4 where they showed a vertical stacking pattern with lateral offset. Abrupt lateral changes in thickness and sedimentary features were occasionally found in the two units. With increasing distance from the Kinu River, the

lower unit showed a slight thinning trend, while the upper unit showed a slight thickening trend along both transects (Fig. 3C). Along Transect N, the lower unit thinned from 28 cm at N8 to 17 cm at N15, while the upper unit thickened from 3 cm at N1 to 12 cm at N10. Along Transect S, the lower unit thinned from 16 cm at S1 to 7 cm at S6, while the upper unit thickened from 8 cm at S1 to 22 cm at S6. At stations N9 and N11, the lower unit was characterized by a series of graded layers, although more commonly, a single inversely-graded layer was present (Fig. 5). In general, the upper unit consisted of a sandy graded layer. However, at stations N1 and N6, the upper unit consisted of either a thin muddy-sand or a sandy-mud layer and transitioned into gravelly sand at station N7 (Fig. 5).

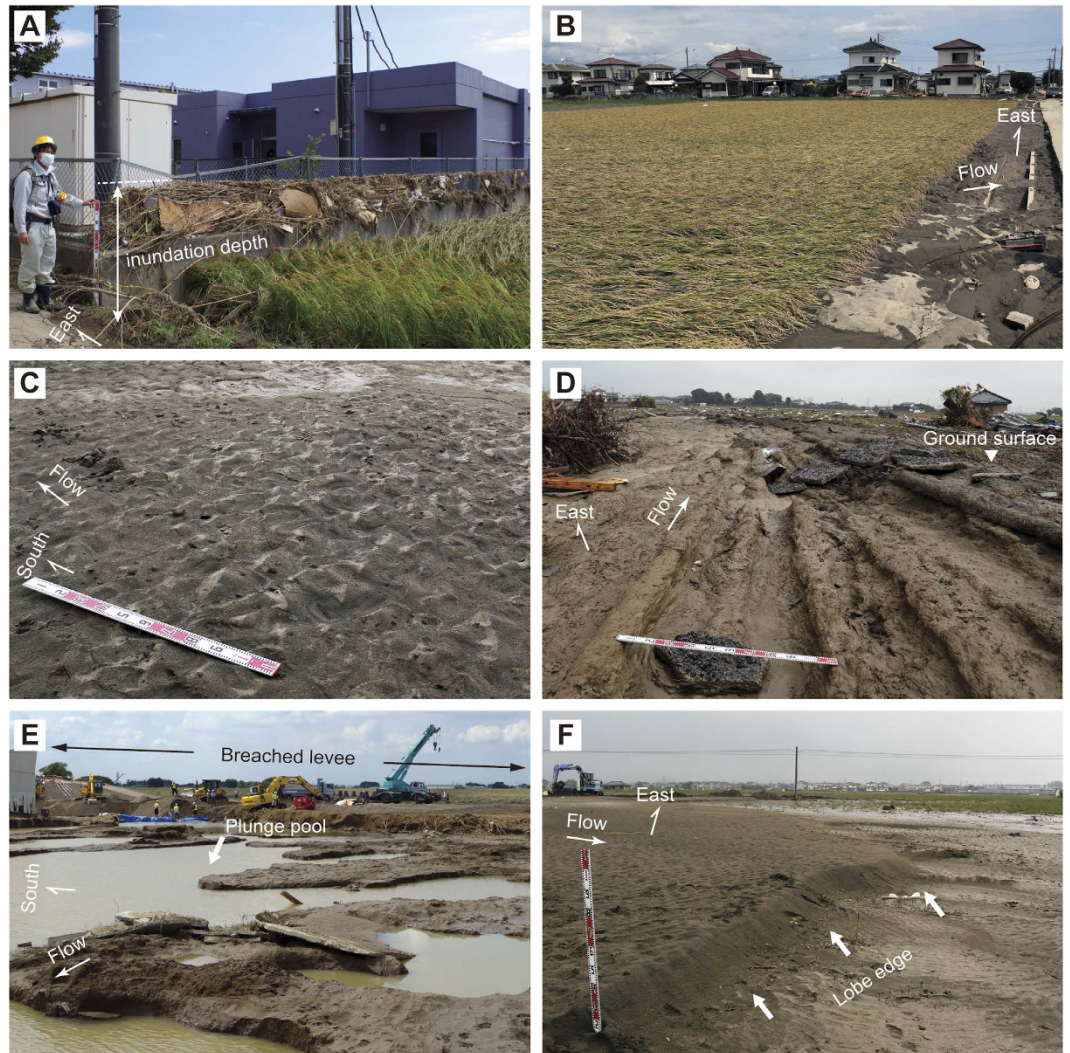
Figure 4. Photographs of the study area. Locations are shown in Fig. 3A (P1–6). The scale bar in panels A, C, D and F represents 1 m. (A) Water-borne debris on the fence at P1 showing the inundation depth of flooding. (B) Leaning rice plants showing the direction of flooding water at P2. (C) Ripple marks on the surface of the flood deposit indicating the flow direction at P3. (D) Linear grooves along the flow direction at P4. (E) Plunge pools scoured by the 2015 flood just behind the breached levee at P5. (F) Lobe edge of the flood deposit at P6.

The latter could be divided into three sedimentary units based on depositional features and grain-size. The basal unit consists of a muddy deposit, while the lower and upper units consist of sandy material. The basal unit contained abundant plant fragments and a higher mud content compared to the other units at S3–5 (Figs 3B and 6). In general the lower and basal units were characterized by distinct inverse grading although normal grading on a smaller scale was observed in some places. (Figs 5 and 6) Parallel laminations with a slightly higher mud content were present with an upward-decreasing trend within the lower unit. At some stations, the lower unit contained small-scale cross laminations, mud clasts and gravel grains. By contrast, the upper unit generally consisted of coarser sand and a slight fining trend in grain size (Figs 5 and 6). Sedimentary structures in the upper unit were variable and include parallel laminations and distinct large-scale cross laminations which reached a thickness of 20 cm at station S4 (Figs 3B and 6). Mud clasts, gravel and a thin mud drape and/or surface ripple marks were also common (Fig. 4C).

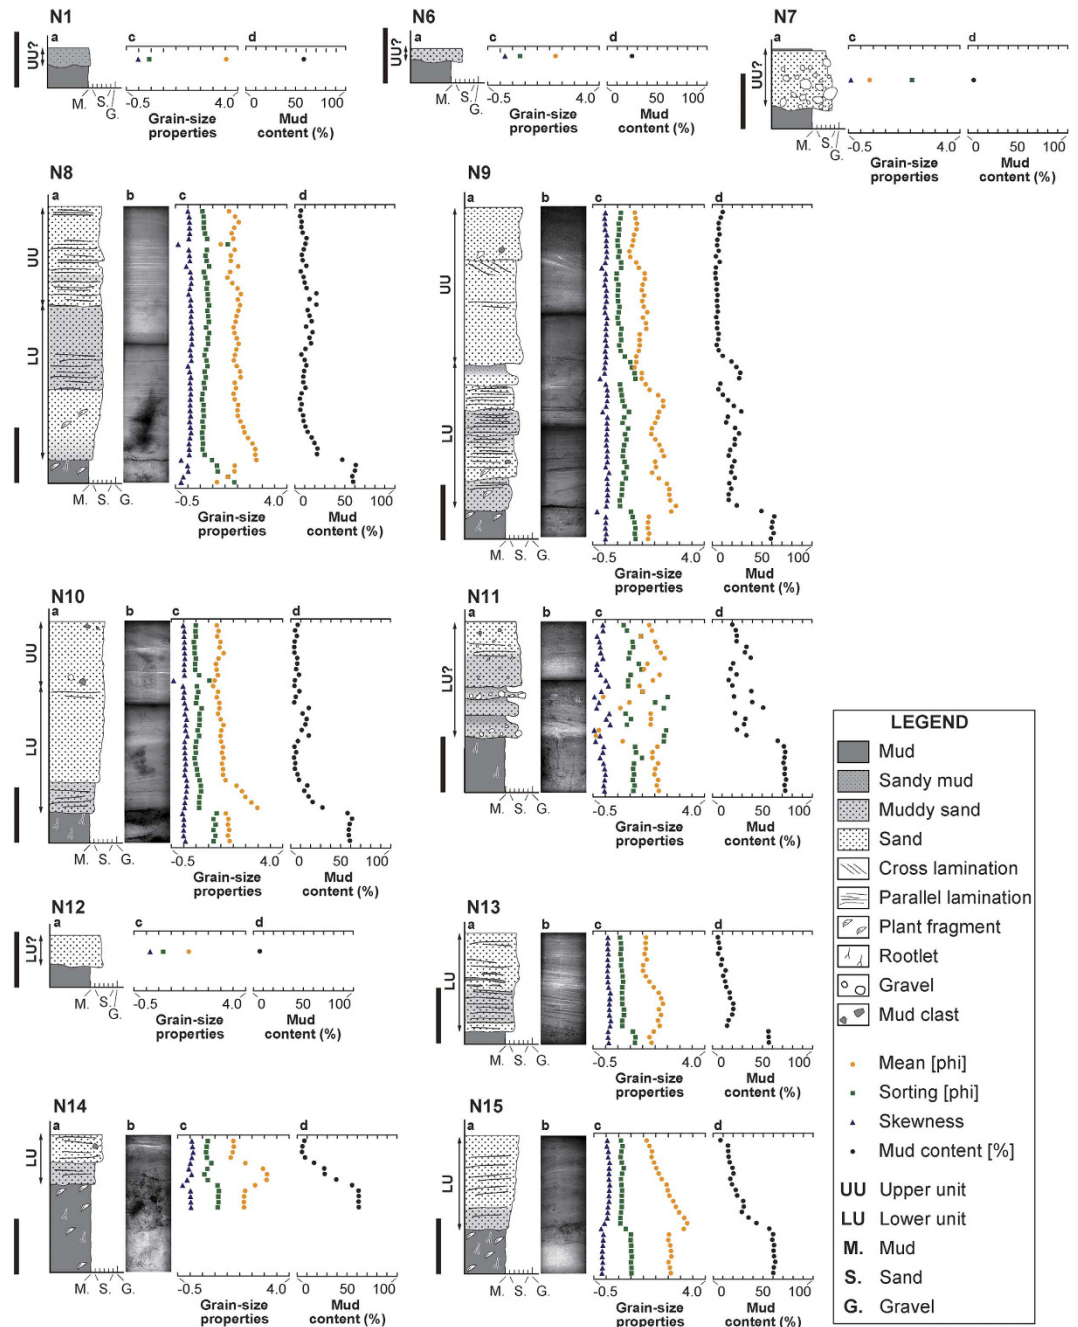
Figure 5. Schematic column (a), soft X-ray image (b), graph of grain-size properties (mean, sorting and skewness) of the particles larger than $63\mu\text{m}$ (c), and mud content (d) of the flood deposit along Transect N (N1, N6–15). The scale bar beside each column represents 10 cm.

higher mud content of 62.55% (Figs 5 and 6). Soft X-ray radiography indicated the presence of mud clasts, gravels, and parallel and cross laminations at various depths in the flood deposits. (Figs 5 and 6).

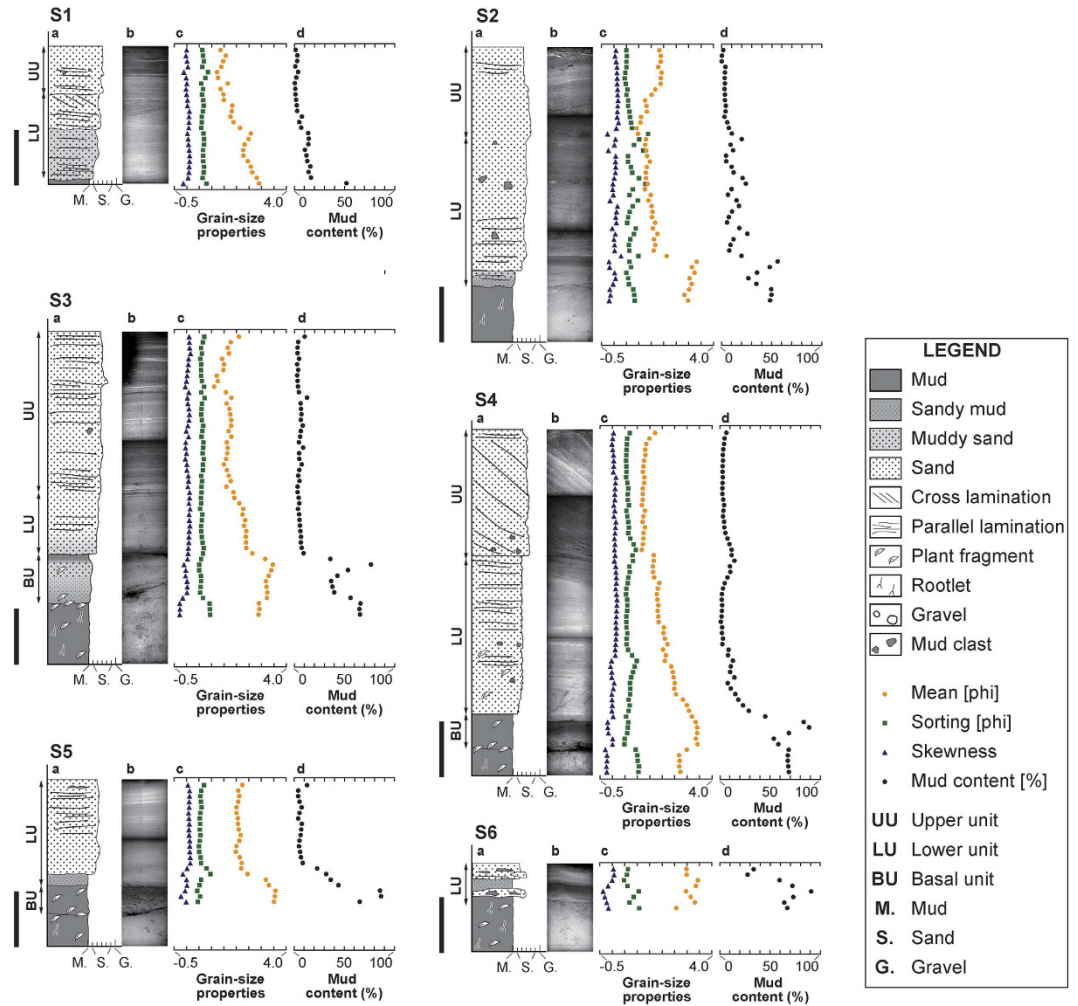
Figure 6. Schematic column (a), soft X-ray image (b), graph of grain-size properties (mean, sorting and skewness) of the particles larger than $63\ \mu\text{m}$ (c), and mud content (d) of the flood deposit along Transect S (S1–6). The scale bar beside each column represents 10 cm.

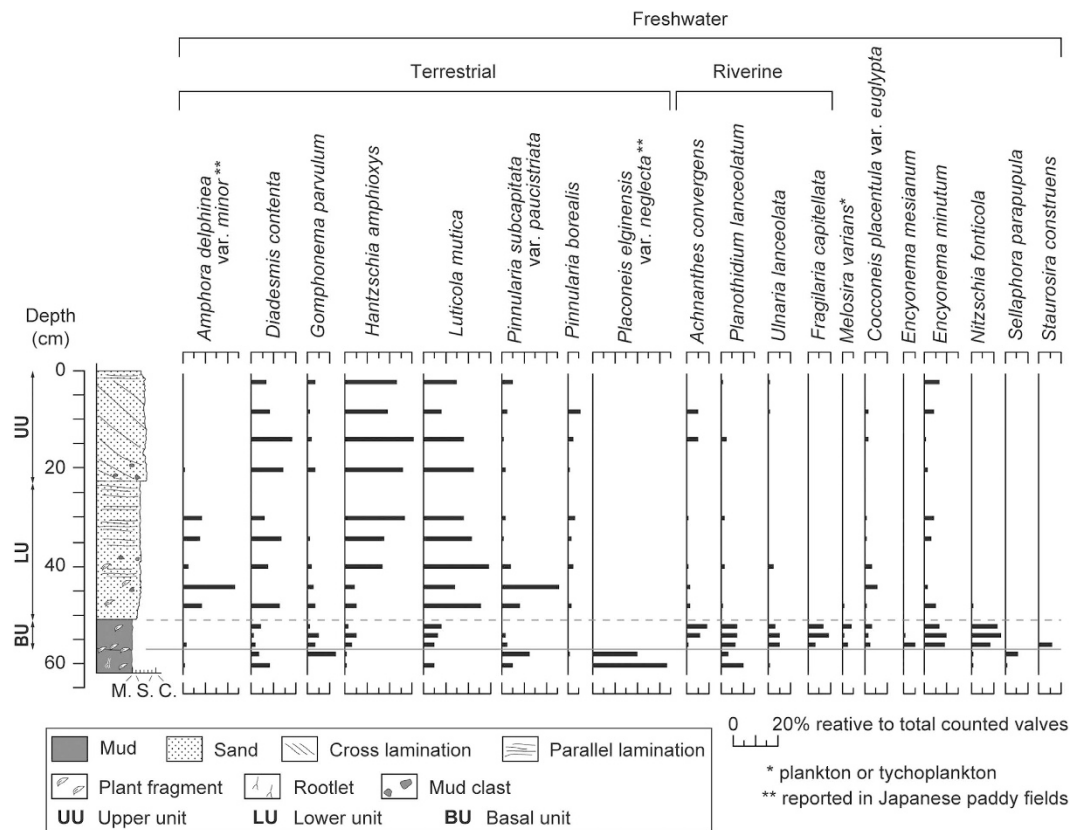
Figure 7. Diatom assemblages for the flood deposit at S4 showing changes in the relative abundance of the dominant species.

Diatom analysis for the deposit found at station S4 revealed that freshwater species were generally dominant, but the species composition of the assemblages varied as a function of the sedimentary facies (Fig. 7). The underlying soil contained many freshwater terrestrial taxa such as *Placoneis elginensis* var. *neglecta*, *Pinnularia subcapitata* var. *paucistriata*, and *Gomphonema parvulum*. These assemblages abruptly changed at the contact between the underlying soil and the muddy basal unit. The basal unit was characterized by riverine benthic diatom species (*Planthidium lanceolatum* and *Ulnaria lanceolata*)¹⁵, other freshwater species, and a decrease in terrestrial taxa

Distinct changes in diatom assemblages are recognized within the deposit at S4. The muddy basal unit of the flood deposit is characterized by a mixture of benthic, planktonic riverine and terrestrial freshwater diatom species. These assemblages were likely to be formed from suspended load due to the initial overtopping of the levee. Because diatom valves are known to exhibit the same depositional behavior as that of silt-sized sediment grains, the dominant species were probably incorporated with the fine fractions of the deposit. The sandy lower and upper units of the flood deposit were dominated by terrestrial diatom species (*Diademsis contenta*, *Hantzschia amphioxys*, and *Luticola mutica*). Such species are commonly found on the surface of wet soils and mosses, but not in coarse-grained sediments^{28–30}. This implies that living diatoms were transported from their original habitat, or pre-existing valves that were buried in soils were scoured, and incorporated with flood sediments during high-energy inundation flow. The observed difference in assemblages can be attributed to the different origins and transportation processes, which are consistent with the depositional processes deduced from the sedimentary features.
