Volume 34 | Issue 1

## Is Temperature, Dissolved Oxygen, or Salinity Driving Oyster Mortality on Breakwaters?

SHORT COMMUNICATION

# IS TEMPERATURE, DISSOLVED OXYGEN, OR SALINITY DRIVING OYSTER MORTALITY ON BREAKWATERS? §

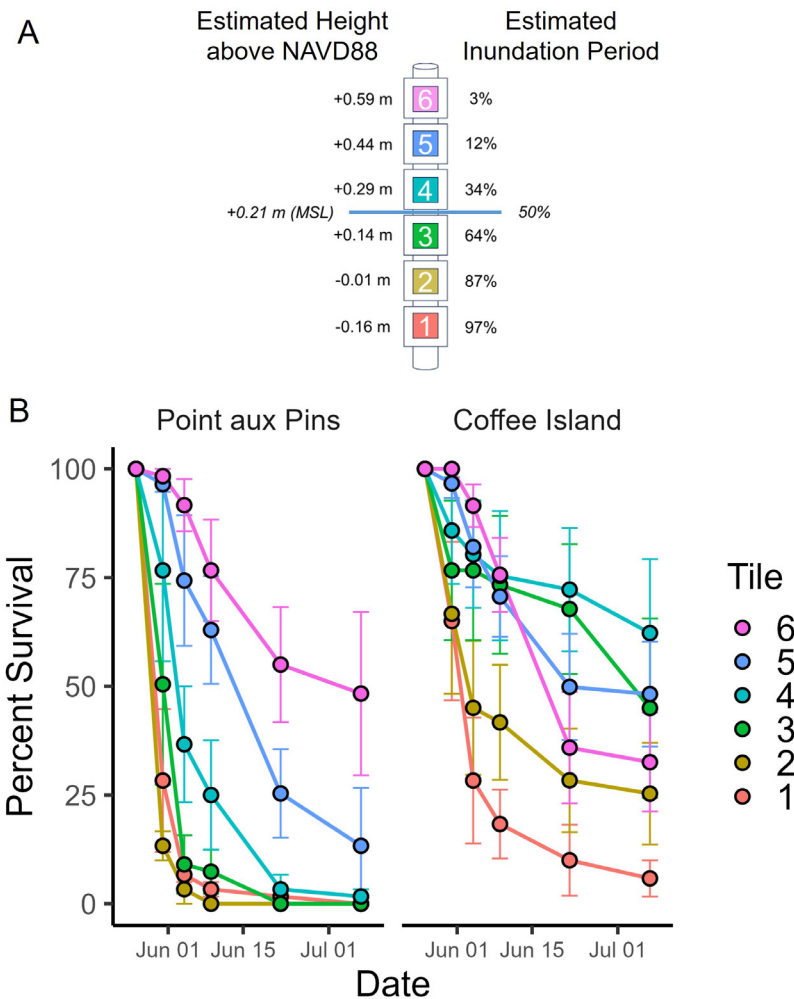
**FIGURE 2.** Tile deployment configuration and survivorship of oyster spat. A. Diagram of the deployment pole configuration. The estimated height (m above NAVD88) and an estimated inundation period based on 3 years of water level data (2020 to 2022, from the National Oceanic and Atmospheric Administration (NOAA) Dauphin Island Station 8735180) for each deployed tile (1 to 6). B. Mean  $\pm$  se survivorship data for seeded oyster tiles, expressed as a percentage of surviving oysters from the initial count on each tile. Circle points represent actual sampling dates, with each tile number represented by differently colored lines, corresponding to A, above. Left: Point aux Pins. Right: Coffee Island.

gradient of fixed intertidal elevations. Each deployment pole consisted of a base pole and a removable segment. The base pole (3.175 cm diameter PVC) was pounded into the sediment to the point of refusal and cut near the water line at the time of deployment (at about mid tide). The height of this base pole was measured in meters above the North American Vertical Datum of 1988 (NAVD88) using a Real Time Kinematic (RTK) Global Navigation Satellite System (GNSS) receiver (Emlid Reach RS2). The removable segment (5.08 cm diameter PVC) was drilled and tapped such that 6 tiles could be fixed to the pole using bolts and washers. In addition, a stopping bolt was installed in the segment based on the height of the corresponding base pole such that, when the segment bolt rested on the base pole, the middle of the tiles was at a target elevation of +0.21 m NAVD88; this elevation was estimated to be the height of 50% inundation based on 3 years of water level data at the National Oceanic and Atmospheric Administration (NOAA) Dauphin Island Station (8735180) (Figure 2A). Therefore, 3 tiles (tiles 1–3) on each pole were expected to be inundated greater than 50% of the time, 3 tiles (tiles 4–6) were expected to be inundated less than 50% of the time, and tile height and exposure treatments were maintained throughout the experiment (Figure 2A).

We observed significant oyster mortalities on tiles, with some tiles experiencing 100% mortality in as little as 5 days of field deployment (Figure 2B). On visit 2 (9 days post deployment, 06/04/2023), there was not a statistically significant effect of Site ( $t_7 = 2.191$ ,  $p = 0.065$ ), although there appeared to be marginally greater oyster mortality at PaP than at CI (Figure 2B). There was a significant effect of Tile number ( $t_{40} = 6.472$ ,  $p < 0.001$ ), as the oysters on the lower tiles died faster at both sites. On visit 5 (42 days post deployment, 07/07/2023), there were significant effects of both Site ( $t_7 = 2.611$ ,  $p = 0.034$ ) and Tile Number ( $t_{40} = 3.069$ ,  $p = 0.004$ ). Overall oyster mortality was greater at PaP by the end of the study period (Figure 2B). For tiles, there was a difference in survival across the tidal elevation range at each site. At PaP, oyster survival increased with increasing height and exposure period (Figure 2B). At CI, oyster survival appeared to maximize on Tile 4, and decreased on tiles below and above Tile 4. Additionally, no new oyster settlement was observed on either the seeded tiles or the unseeded tiles during this monitoring period.

July only, while salinity was never observed below 5 during this monitoring period (Figures 3A and 3C). For DO, oysters have been observed withstanding concentrations of 1 mg/L DO for 5 d (Sparks et al. 1958). Hypoxic conditions were occasionally observed over the monitoring period at various sites, including 1 mg/L DO; however, such conditions never lasted more than a few days (Figure 3B). Therefore, we infer that neither water temperature, DO, nor salinity could account for the significant mortalities observed on the oyster tiles during this monitoring period. In fact, water quality appeared to be within oyster tolerance limits during the early stages of the experiment, during which significant oyster mortalities were observed shortly after deployment (Figure 2).

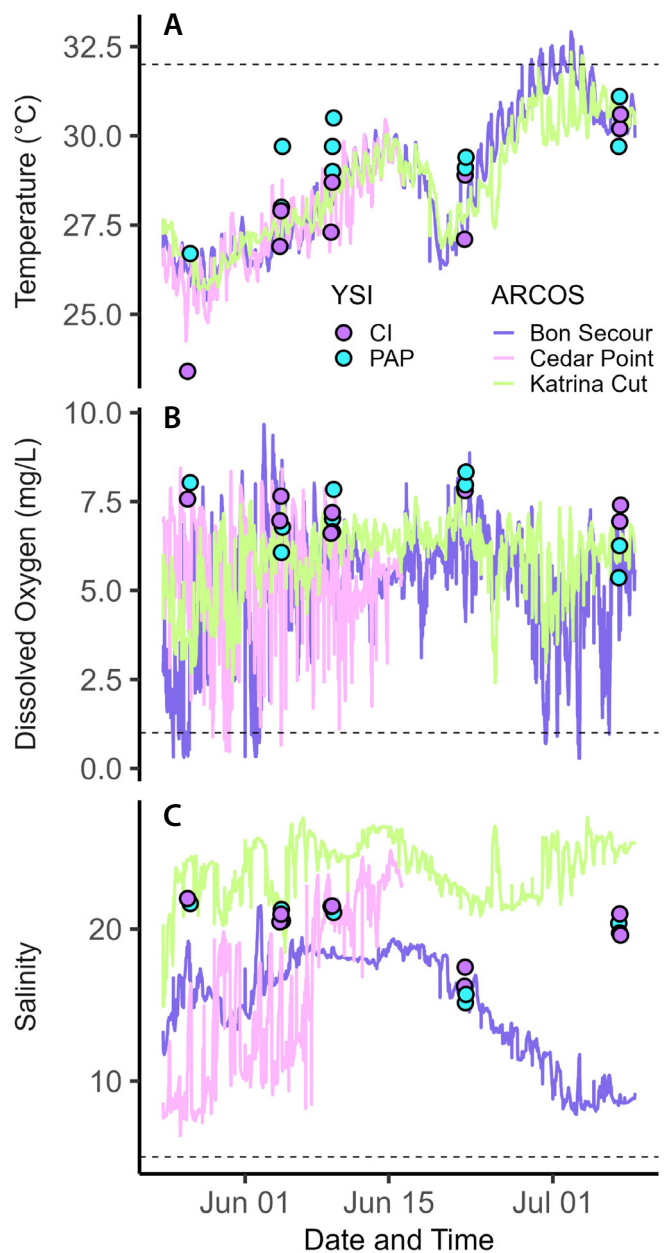
**FIGURE 3.** Water quality data collected from onsite YSI readings (points) and continuously from ARCOS stations (lines). A. Water temperature. B. Dissolved oxygen. C. Salinity. Dotted lines indicate values considered to represent potential lethal limits for oysters (temperature: 32°C, dissolved oxygen: 1 mg/L DO, salinity: 5, see text for details).

Water quality was variable over the monitoring period and between sampling sites, but the onsite measurements were generally in the range of the continuous measurements (Figure 3). In this study, our aim was to determine whether measured water quality values likely represented extreme values that could lead to the oyster mortalities observed in this study. Therefore, we compared measured water quality to water quality values that have been reported as being relevant for oyster mortalities.

Rybovich et al. (2016) observed significant mortalities in spat and seed oysters subject to combinations of extreme temperatures (32°C) and low salinities (1, 5). Although oysters can occasionally survive at these extreme temperatures or salinities, they are more likely to become stressed and may die, especially if exposed to a combination of stressors (Rybovich et al. 2016). Therefore, we considered 32°C to represent a conservative lethal upper limit for oysters (Figure 3A), and salinity 5 to represent a conservative lethal lower limit for oysters (Figure 3C). Temperature was observed to briefly exceed 32°C in early

Although water quality did not likely directly drive oyster mortality observed during this experiment, water quality could have had important indirect effects on oyster biology. For example, oyster larvae are much more sensitive to low DO concentrations than adults, failing to settle and dying more quickly under hypoxic conditions (Baker and Mann 1992). If the occasional hypoxia measured at some of the ARCOS stations also occurred at the monitoring sites, the hypoxia might explain why no new oyster settlement was observed. Oyster spawning can also be inhibited by prolonged exposure to fresh water (Butler 1949), though this was not observed during our
